Statement of Significance- Holy Trinity Church, Hartshill (Revision 5, 16/11/2025)

<u>1.The Church in its environment.</u>	<u>Pages</u>
1.1 Setting of the Church.	2 to 5
1.2. The Living Churchyard.	6 to 8
1.3. Social History.	9
1.4. The Church Building in general.	10 to 14
1.5. The Church Building in detail.	15 to 24
1.6. Contents of the Church.	25 to 27
1.7. Significance for Mission	28
<u>2. The significance of the area affected by proposals</u>	
2.1. Identification of the parts of the church and churchyard affected by the proposals.	29 to 30
2.2. The significance of these particular parts.	31 to 36
<u>3. Assessment of the impact of the proposals.</u>	
3.1. The impact of the proposals on these parts and the whole.	37 to 38
3.2. The Mitigation to reduce impact of proposed works on the significance of the parts affected and the whole.	39
Appendix 1- English Heritage Listing	40
Appendix 2- Quinquennial Report Recommendations	41 to 42

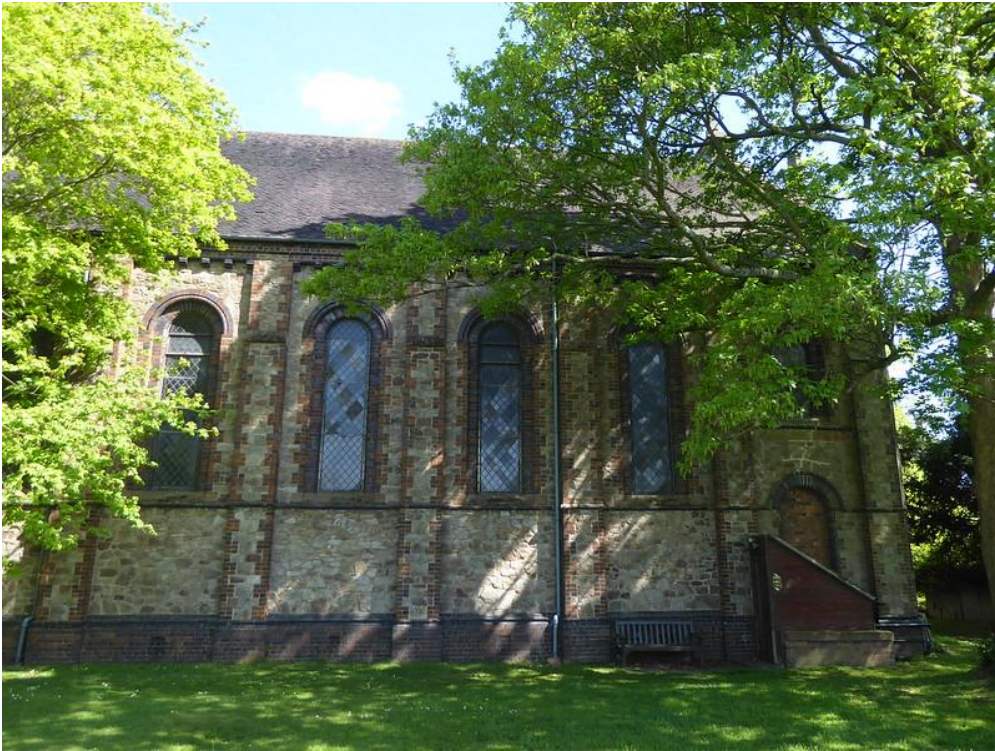
Southern elevation.

The north, south and east walls are plainer, constructed of brick quoins/piers and stone infill and the areas in between with local quarry stone. The walls have a plinth of blue bricks and blue brick string courses and corbelling. The tall but narrow lead windows have a blue brick arch course over the windows. There are two bricked up doors in the south and north elevations at the eastern end. Above those are smaller windows. In front of the bricked-up door on the southern elevation is a wooden sided porch in front of the boiler house which is below ground level.

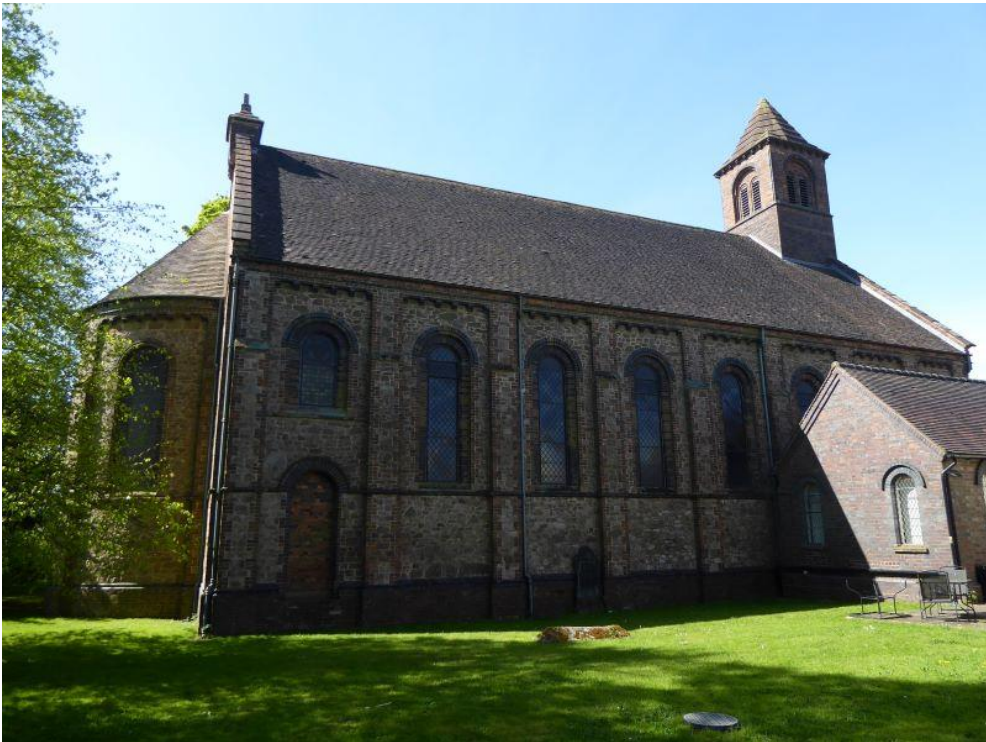
The north elevation of the Church has the same design and architectural features as the south elevation. The rear of view of the Vestry is also visible and is in character with the Church.

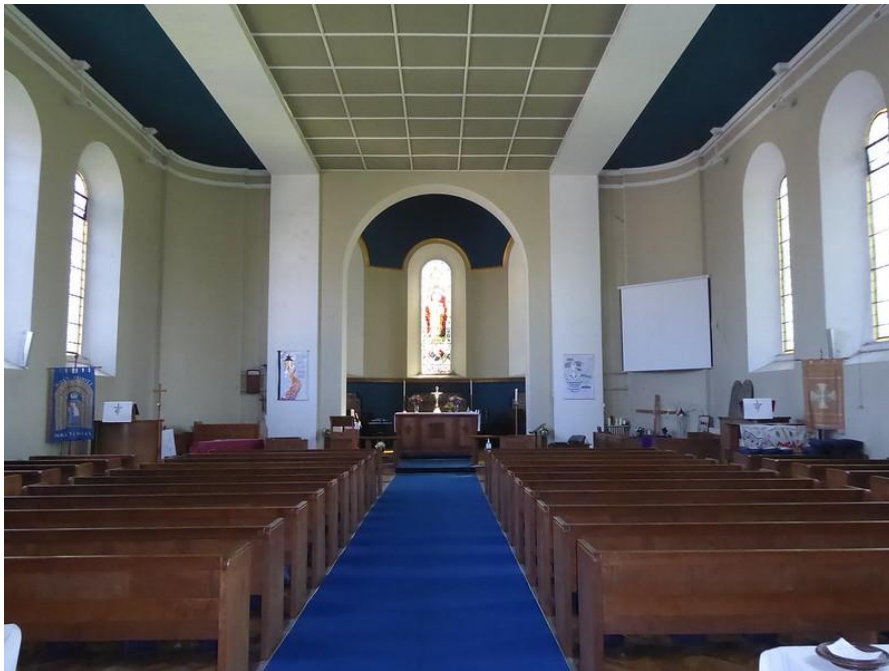
At the western end there is a gallery which originally had seating which contributed to the capacity of the church. On the front part of the gallery the seating is still in place. A partition separates the front part of the gallery from an area in front of the large Rose window. This sealed off area also has some of the original steps (but not the seats). The organ pipes are centrally placed and are a prominent feature.

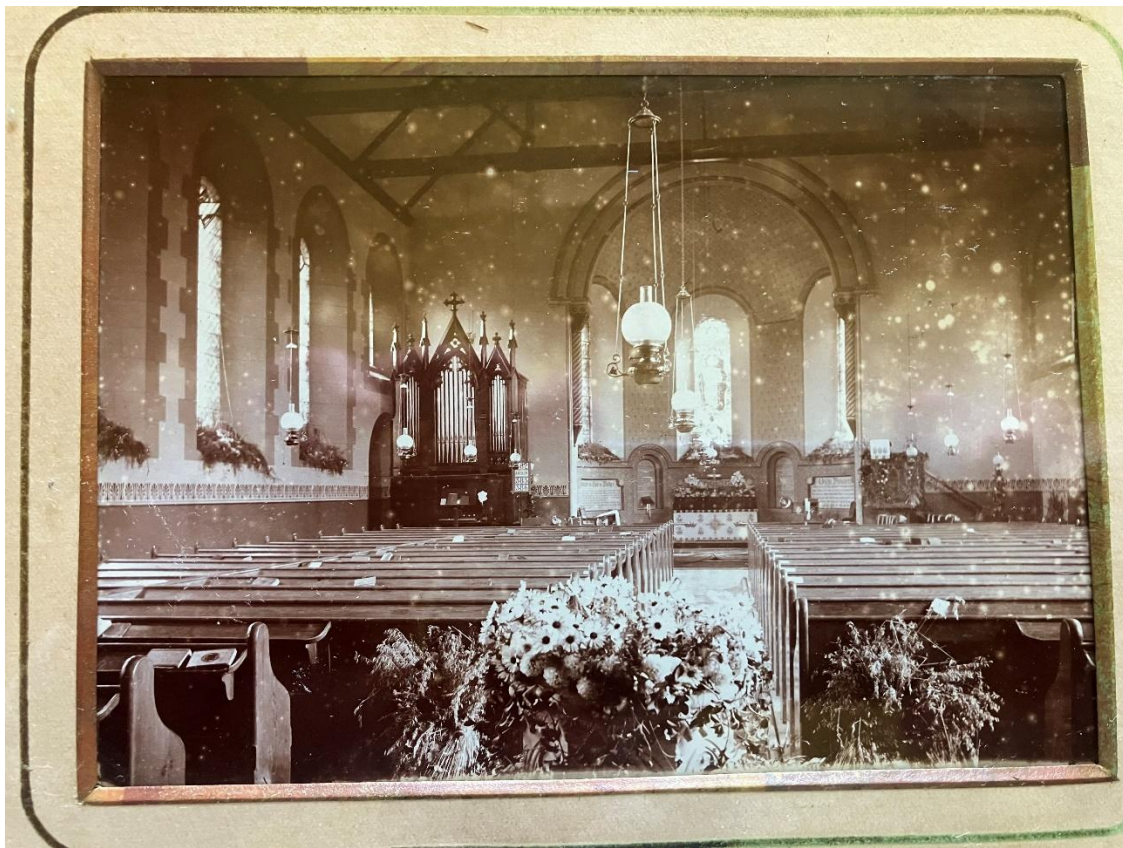
There are some old photographs stored in the Church which showed the interior as it looked when built in 1848. One of the clearer photographs dated 1913 is titled 'Holy Trinity in the days of oil lamps.'

All the original pews were of white pine. Some of the centre seats had panels as they were rented seats. The roof space was open, supported by heavy beams from which hung chains with the paraffin lamps and their ruby-glass vessels. In the northeast corner stood a pipe organ. Choir stalls were of a bench type.

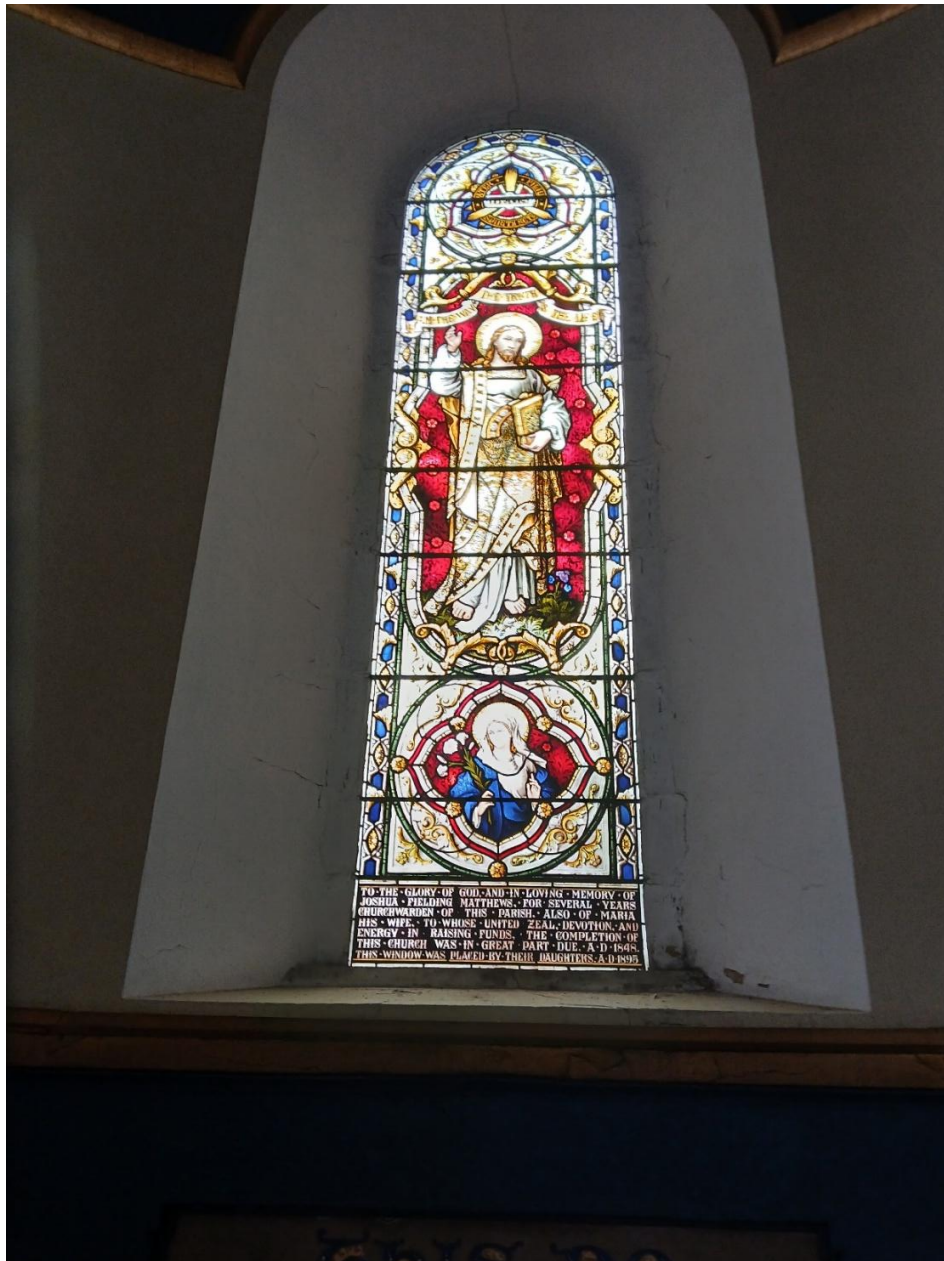
Central Window- This was installed in the middle window in 1895 in memory of Joshua Fielding Matthews and his wife Maria and was given by their two daughters. The figure is Christ.

The apse contains the three beautiful, stained-glass windows referred to in section 5. Nick Bayliss (Architectural Glass Ltd) who was consulted on the leaded windows in north and south elevations, identified these 3 windows as Hardman's windows. There is the name of Hardman in small print on the north window (St Agnes).

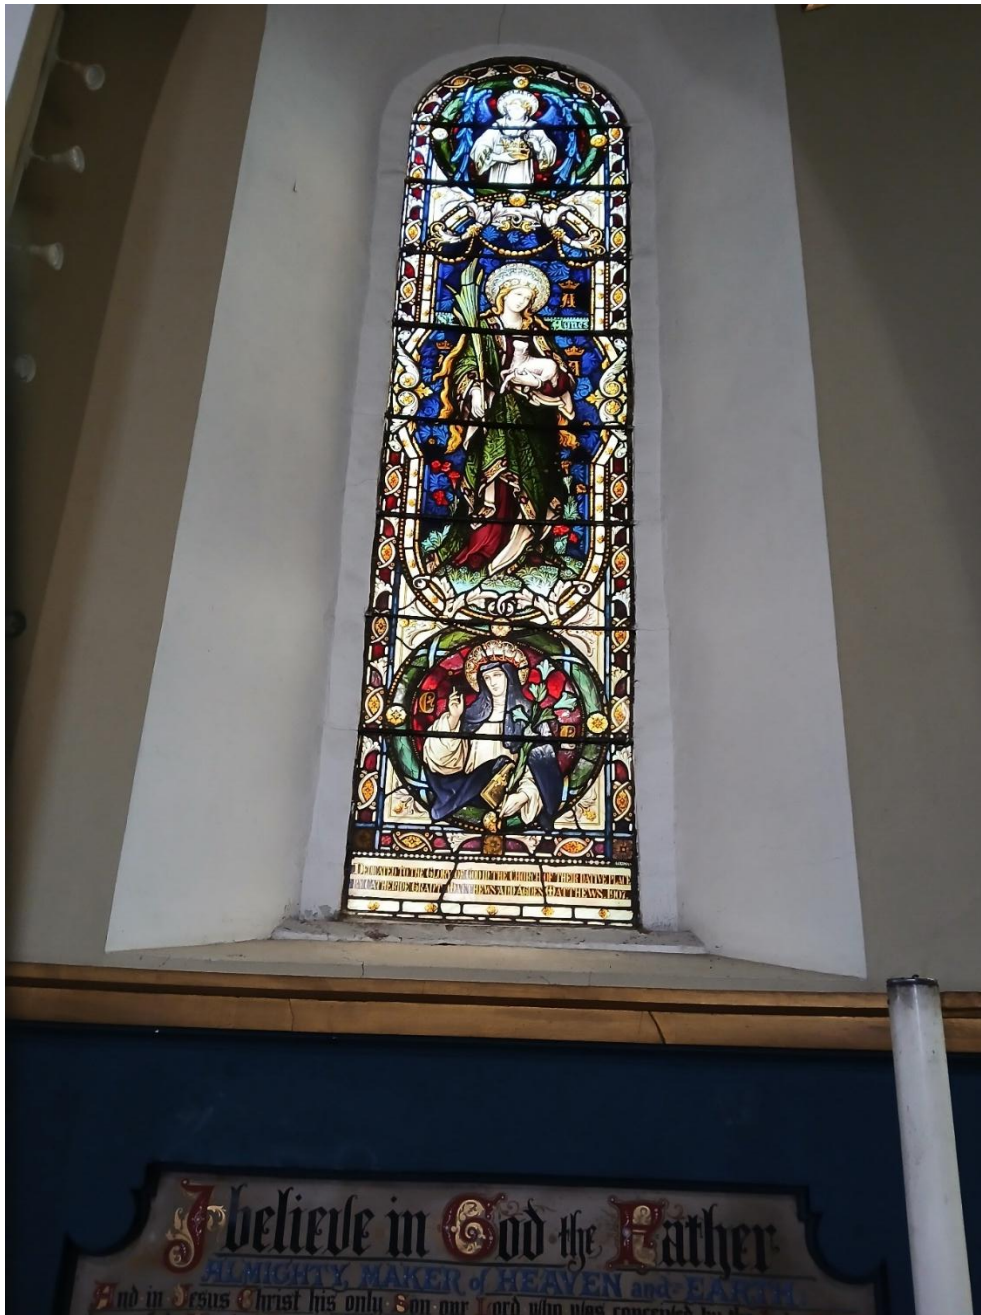
North Window installed in 1907 in memory of Catherine Grant Matthews and was given by two daughters. The figures are Saint Agnes and Saint Catherine.

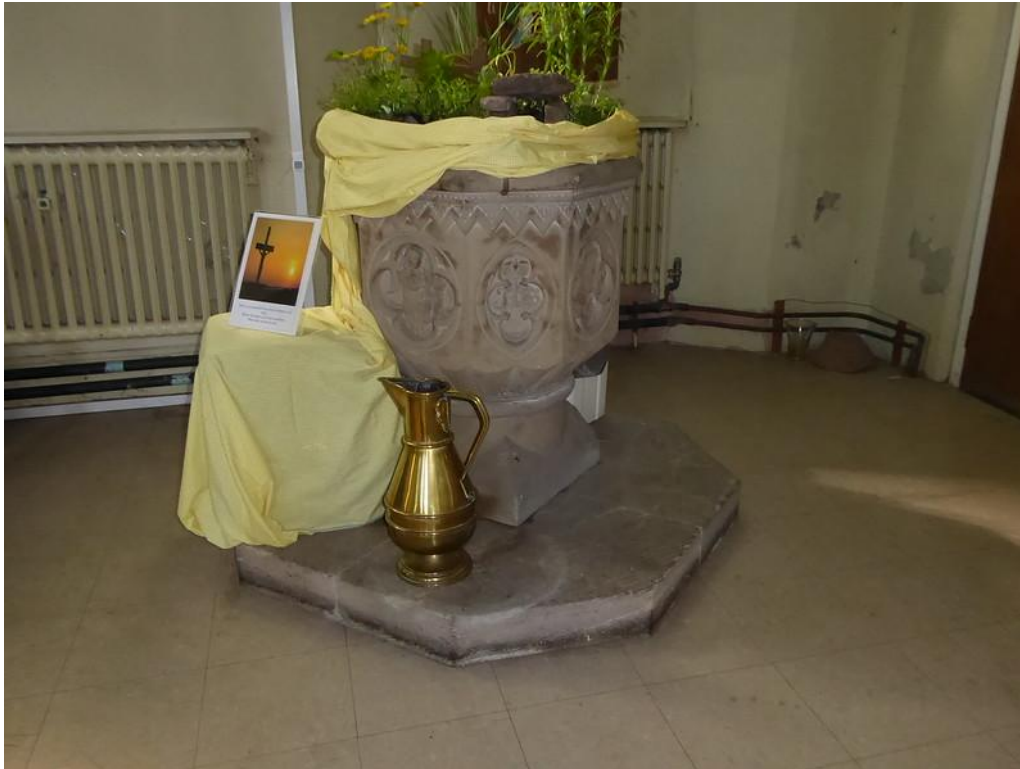
The large font in the south-west corner of the Nave is hexagonal and stone with carved symbols and figures in the 8 sides. It sits on a stone plinth 12cm high.

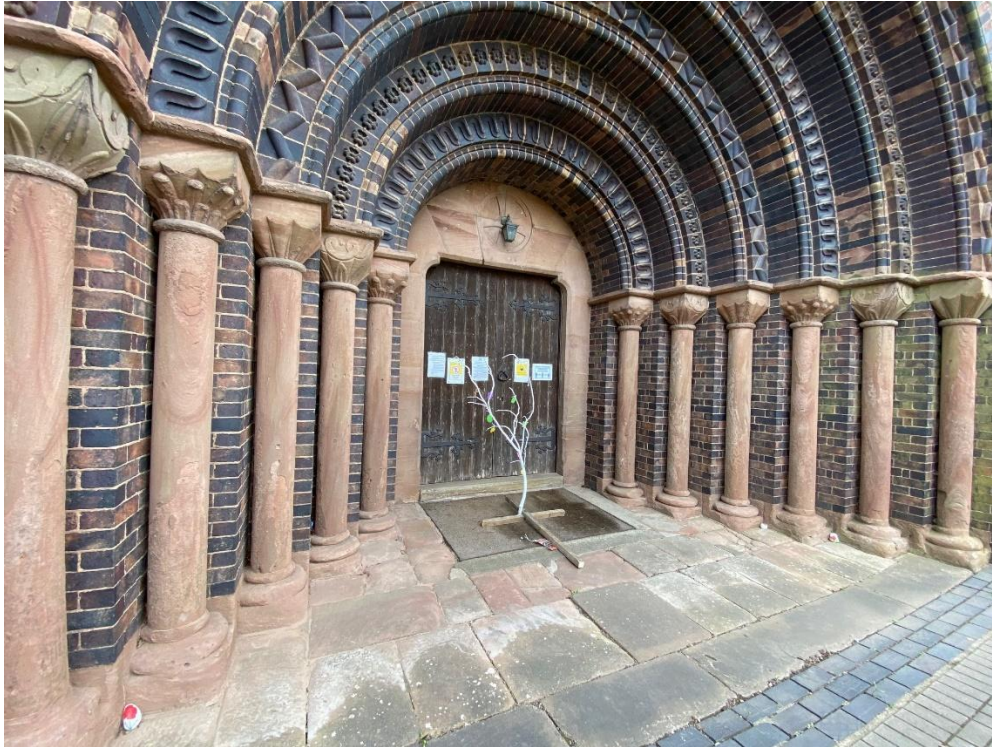
The appearance of the west elevation is of particular note with its large entrance with recessed doors, sandstone pillars and prominent brick patterned arches.

Above the entrance is an attractive and large sandstone rose window and above that a smaller louvred round window to the bell chamber and above that is an attractive small square tower and spire.
